Paso Robles – Vine Street 32nd to Caballo Road

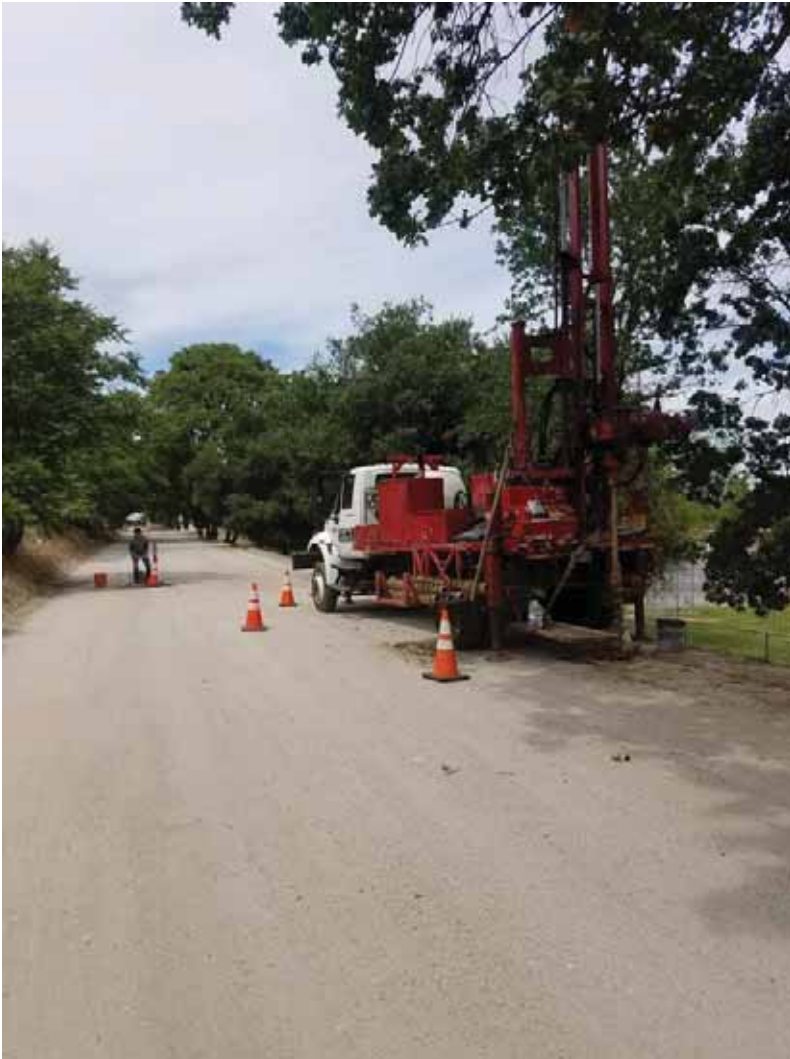
Performing infiltration test to determine permeability of existing soil in bore hole (left) and preparing to drill another hole (right)

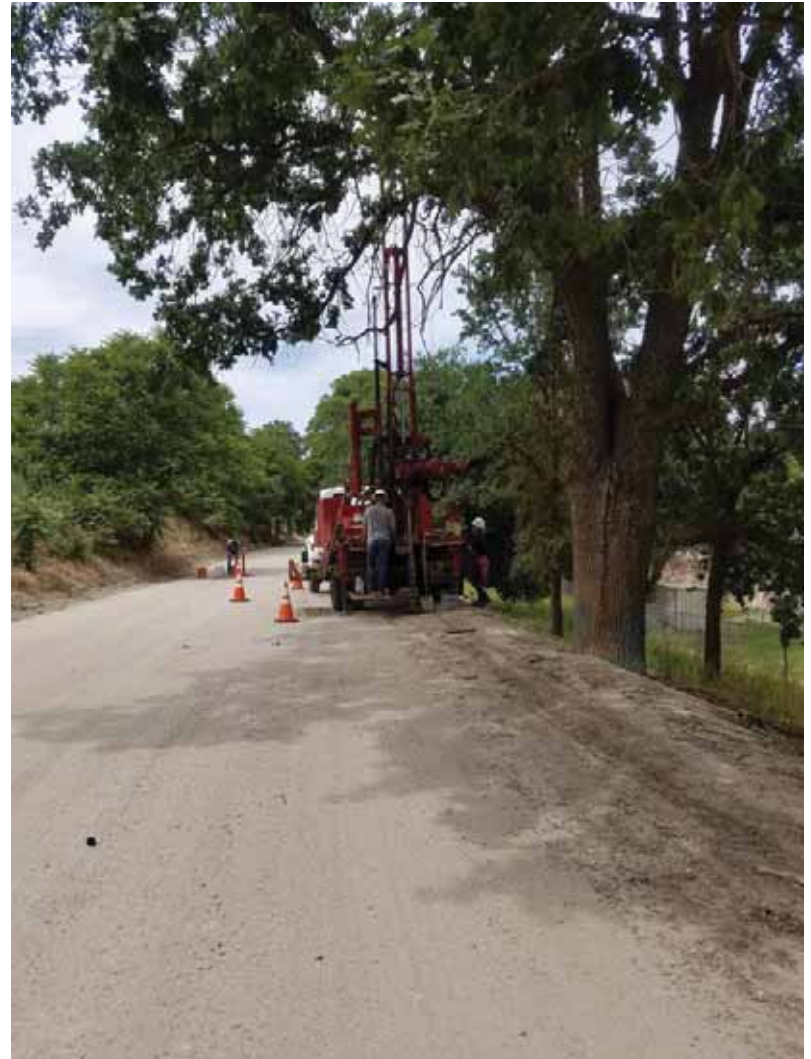
Looking North on Vine towards Caballo Road

Boring an infiltration test pit at the shoulder of the road

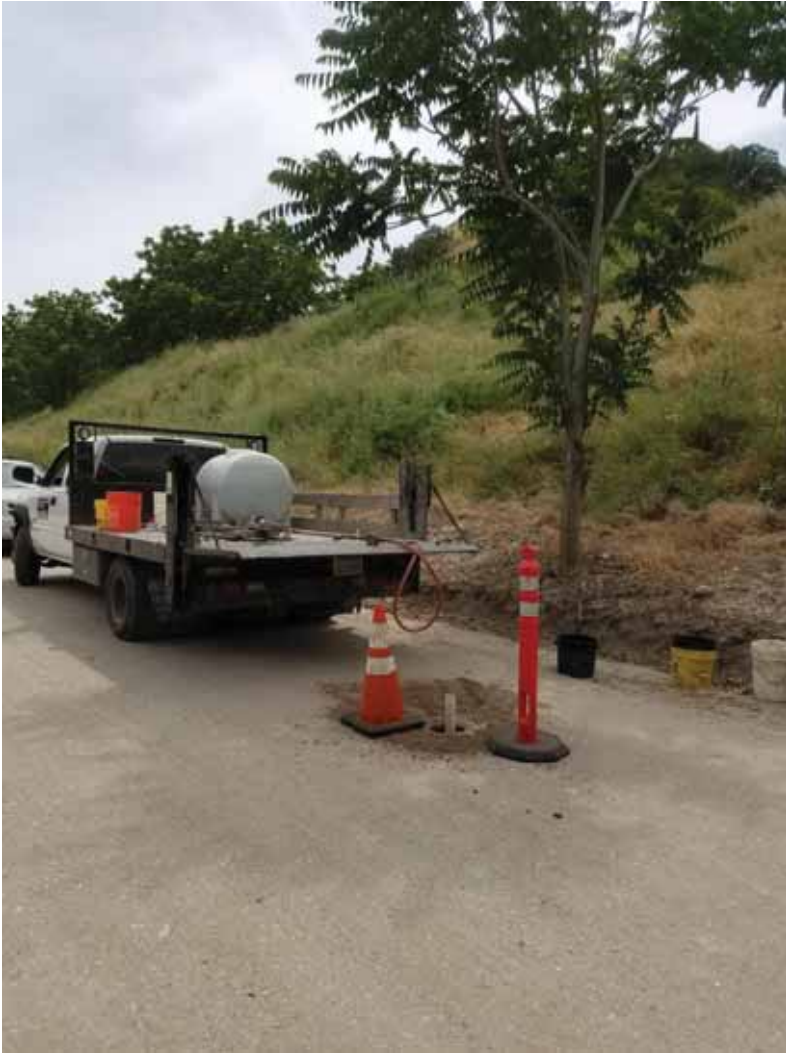
Infiltration test in progress

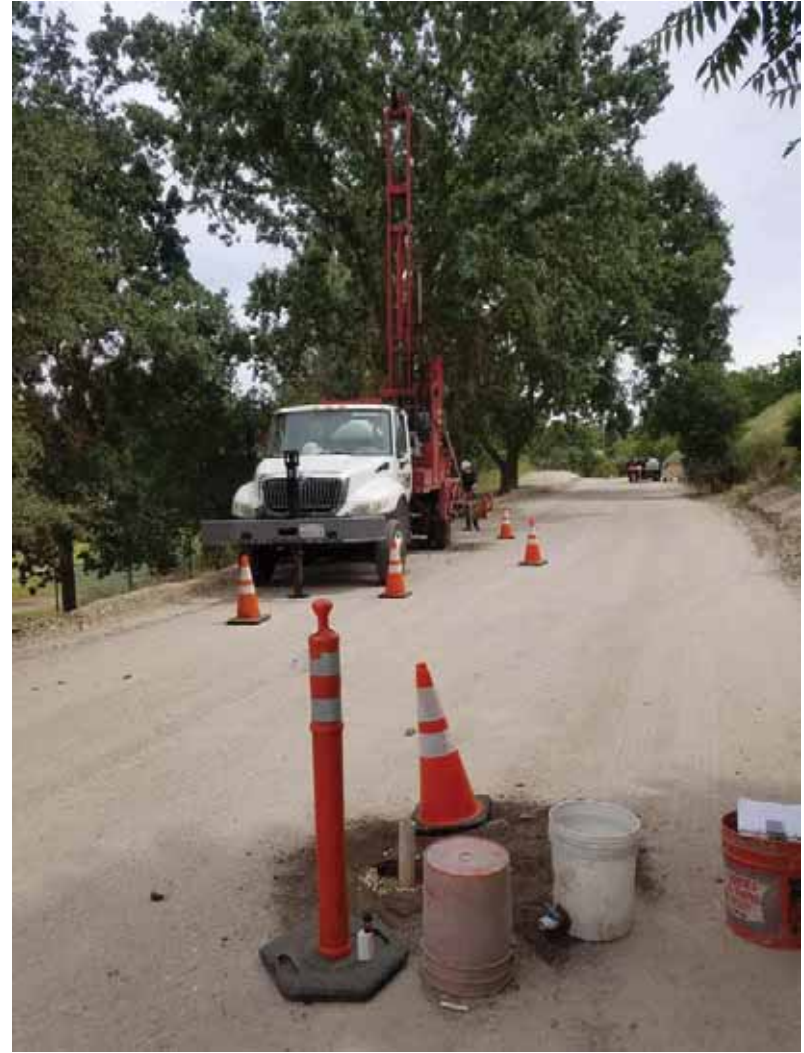
Looking south on Vine towards Arleen Street

Infiltration test with drilling rig in background
