**TECHNICAL MEMORANDUM DISCUSSING
PRELIMINARY GEOTECHNICAL ENGINEERING
CONSIDERATIONS FOR THE CHANDLER RANCH
DEVELOPMENT IN PASO ROBLES, CALIFORNIA**

Prepared for:
DEL WEBB COMMUNITIES, INC.

October 1995

FOR THE
CHANDLER RANCH PROPERTY

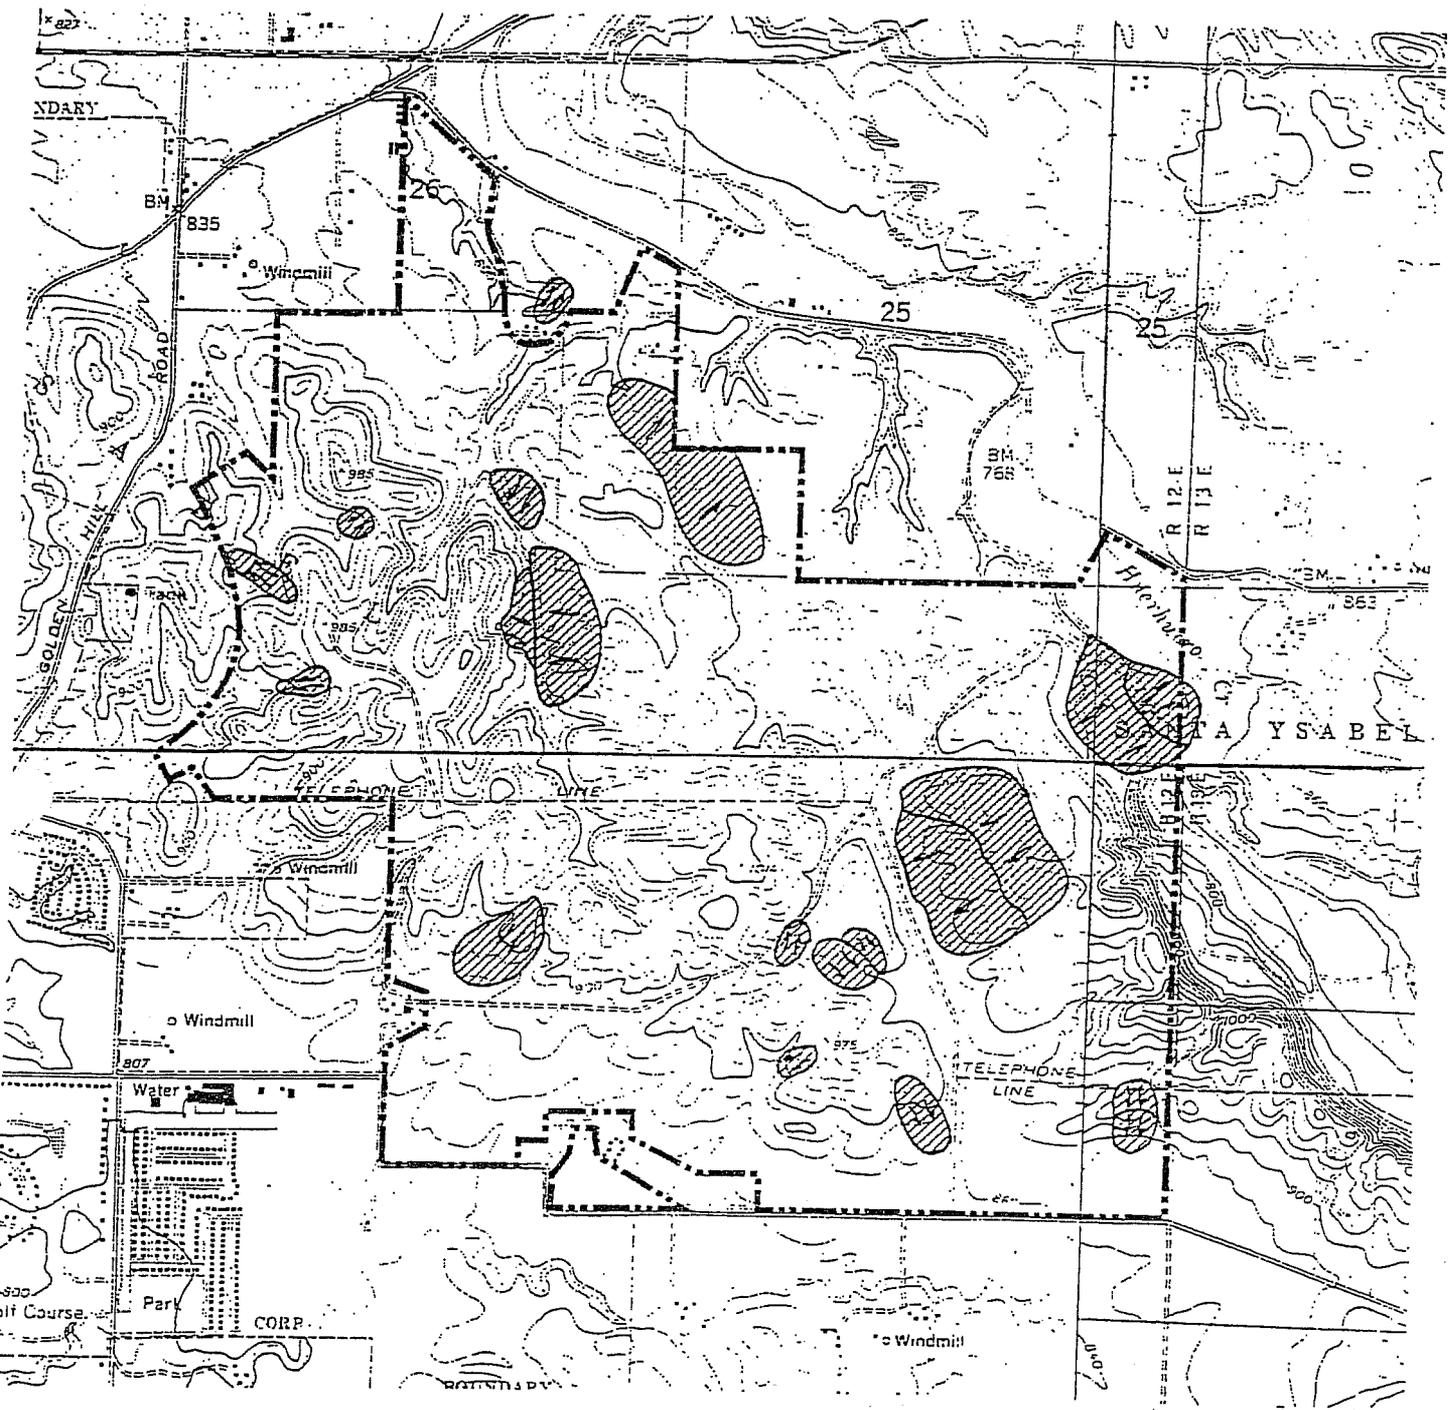
8. Older landslides have also been mapped at various locations over the site, as indicated on Plate 4. Because of the extensive nature of the proposed cut and fill grading, we suspect that many of the older landslides within the interior of the project are likely to be buttressed by the planned mass grading. However, older landslides on slopes

- Caution should be exercised so that excavations do not result in the removal of existing support material from the toes of the slides such that planes of potentially weak material associated with past movement of the landslides are exposed in cuts; and
- Caution should be exercised so that grading does not result in surcharging of the heads of landslide deposits.

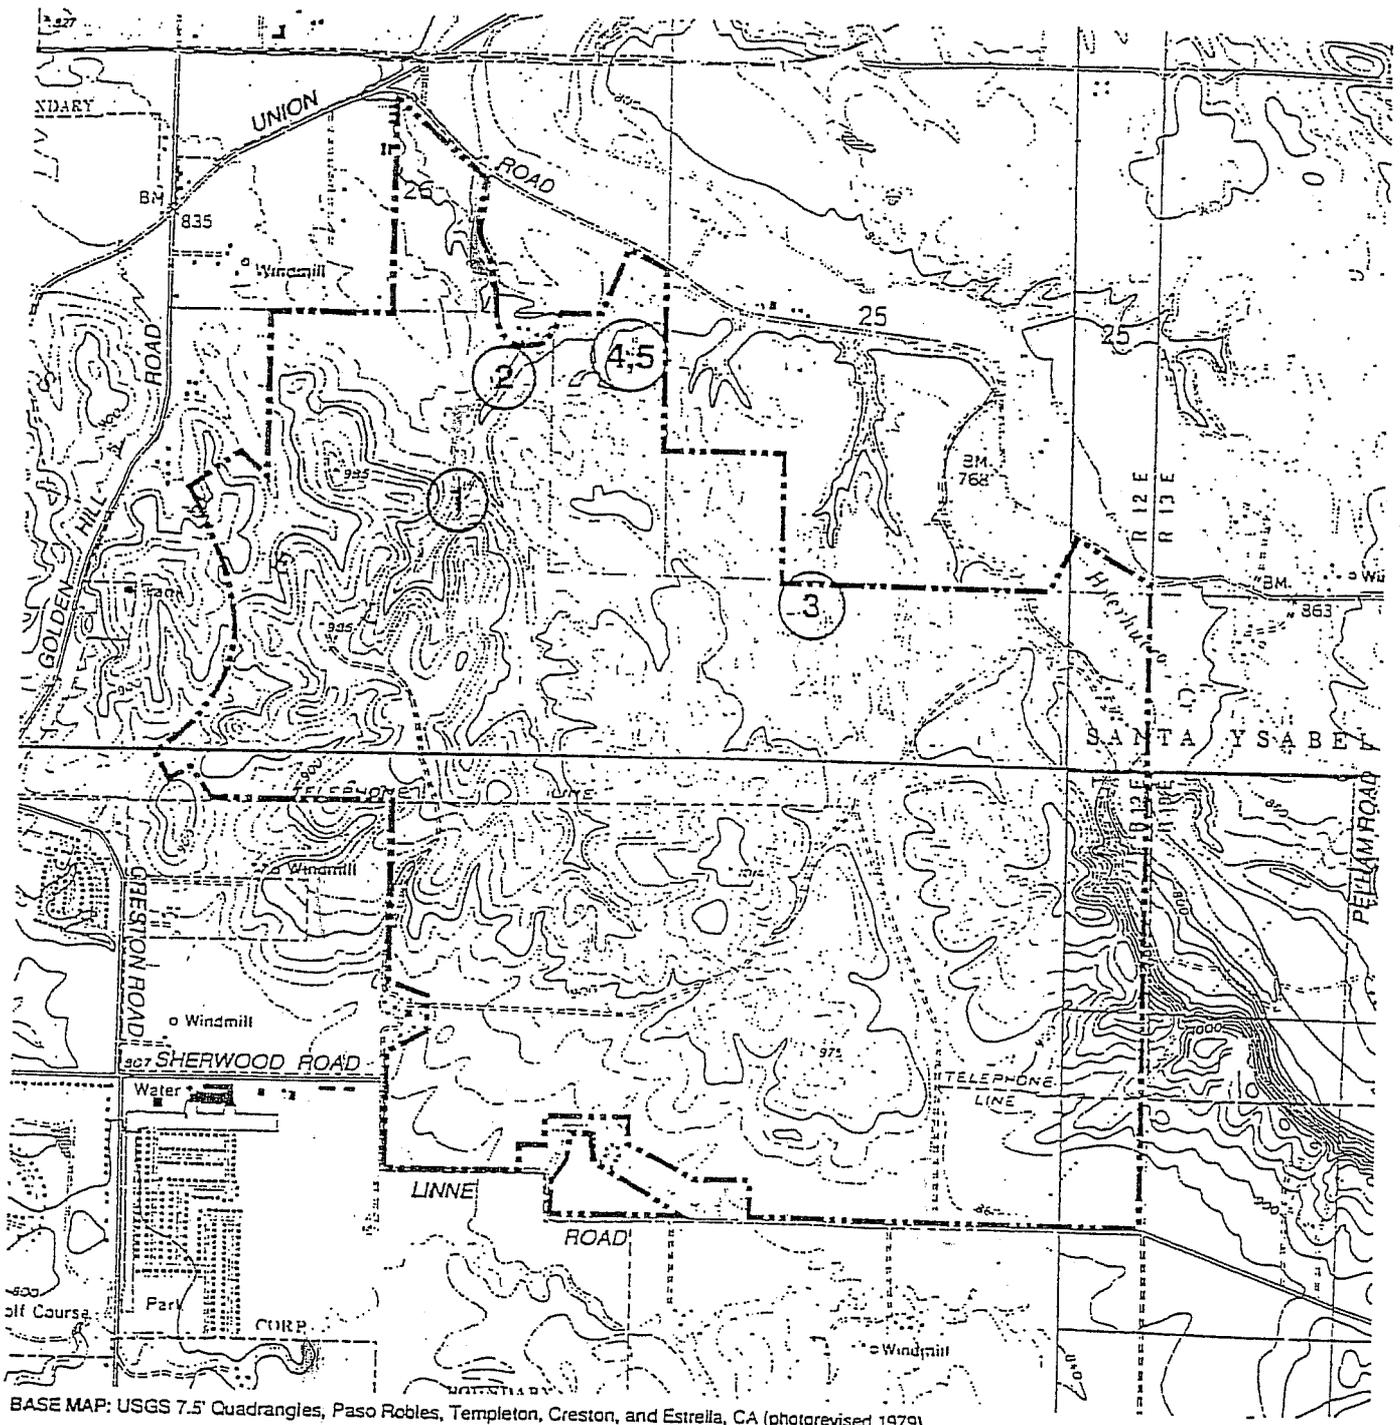
Area 1 - Trash dump located at the head of a north-south trending stream canyon located along the east side of Parcel 3. A dump containing household trash and ranch materials was observed at the head of the drainage where it intersected one of the ranch roads. Among the items observed were multiple 55-gallon, 30-gallon, 10-gallon, and 5-gallon containers and drums. The containers did not have content labels, however, they appeared to be typical of containers used for storing paints, chemicals, and petroleum products. Observations indicated that more materials may be buried under the trash pile and in the sediments deposited in and along the stream channel.

Area 2 - Trash and debris along the north-south trending stream canyon located along the northeast corner of Parcel 3. Scattered trash consisting of old gas cans, 30-gallon drums and automotive parts was observed. Observations indicated that additional trash and debris may be buried under sediments accumulated in and adjacent to the stream channel.

Area 3 - Two, 55-gallon drums in the confluence of two stream canyons located in the northwestern portion of Parcel 10. The drums appeared to contain some quantity of fluids (3 to 8 gallons estimated) and were capped. One of the drums was observed to have a black oily fluid on the inside of its cap and emitted a heavy hydrocarbon-like odor. Our observations of the ground adjacent to the drums did not indicate that the drums had leaked, however, the presence of leakage could be undetected at the site reconnaissance level conducted.

Area 4 - Small trash dump in the north-south trending stream canyon located on the north side of Parcel 5, just west of an existing house and barn complex. The trash observed in this area consisted primarily of old bottles, an old washing machine, bed springs, and some paint-can-type containers. Observations indicated that additional trash may be buried in the vicinity of

Area 5 - An apparent open well located in the house and barn complex in the north portion of Parcel 5. Adjacent to a functional, sealed well, we observed a 5- to 6-inch diameter pipe that, based on our observations, appeared to extend well below ground. The pipe was not dissimilar to the piping observed on the nearby functional well. The pipe was not capped. While the open well does not itself pose a threat to the integrity of the property, it potentially provides a direct vertical pathway to the subsurface for materials placed in the well. In addition, this well is readily accessible to the general public from Union Road.

- Remove the trash dump areas from the site. Removal should be conducted by a qualified firm experienced in working in areas containing potentially hazardous materials. Drums and other potential contaminant-containing containers should be segregated. Fluids contained in containers should then be sampled and analyzed to assess their chemical nature. The drums and container locations should be mapped to help in assessing future soil sampling locations beneath the dump. Sampling and testing should then be conducted to assess for the presence of contaminants in the potentially impacted soil and stream channel sediments.
- We recommend that the well pipe on Parcel 5 be capped with a locking seal. The fluids in the well should be sampled and tested to assess for the potential presence of contaminants.
