Paso Robles 2016 – Spring Street, 1st to 10th – DPW 12-12F-2

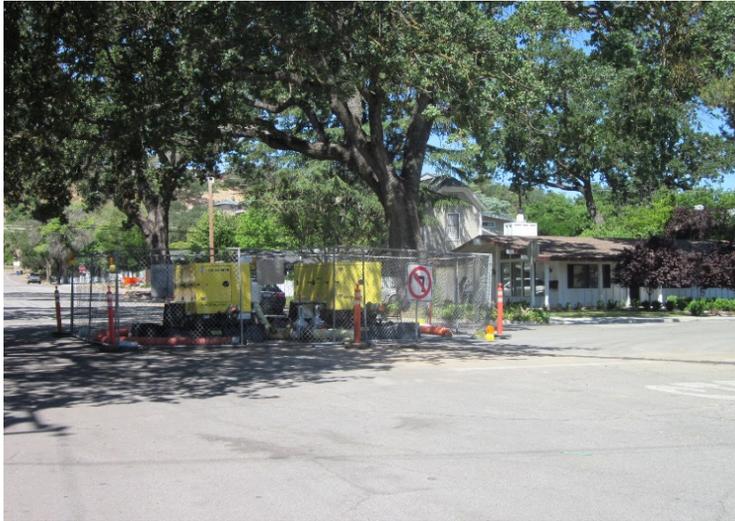
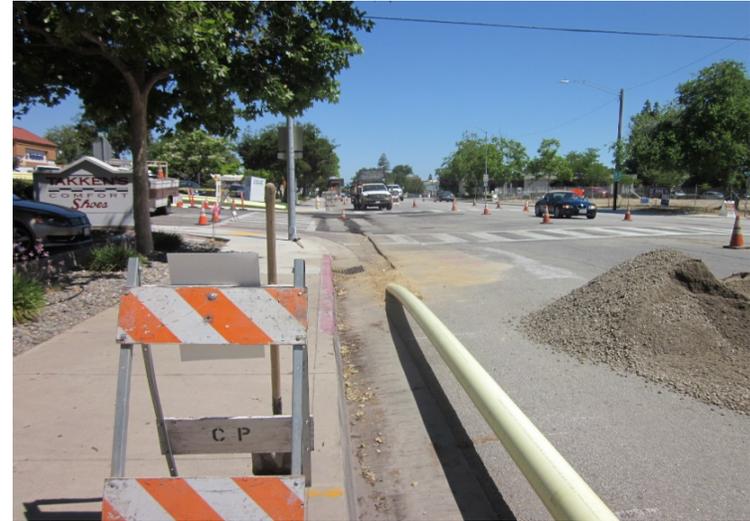
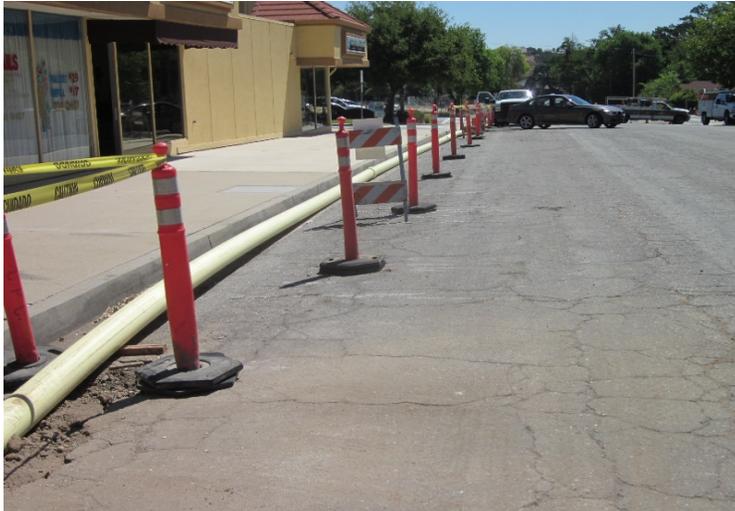
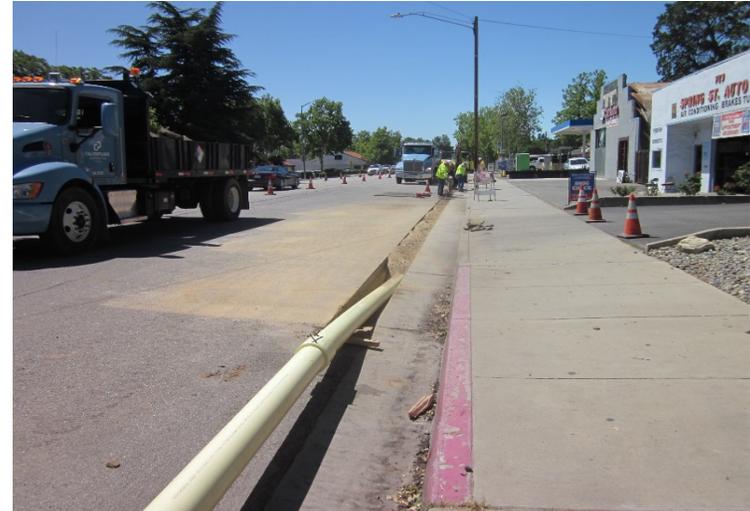
Work is underway to repair Spring Street – 1st to 10th. Contractor is placing a temporary sewer by-pass system at 8th Street. Once the temporary system is in place, then the existing sewer main will be disconnected from service, and will install the new mains at manholes (as the existing are old and need to be replaced). (05/17/2016)

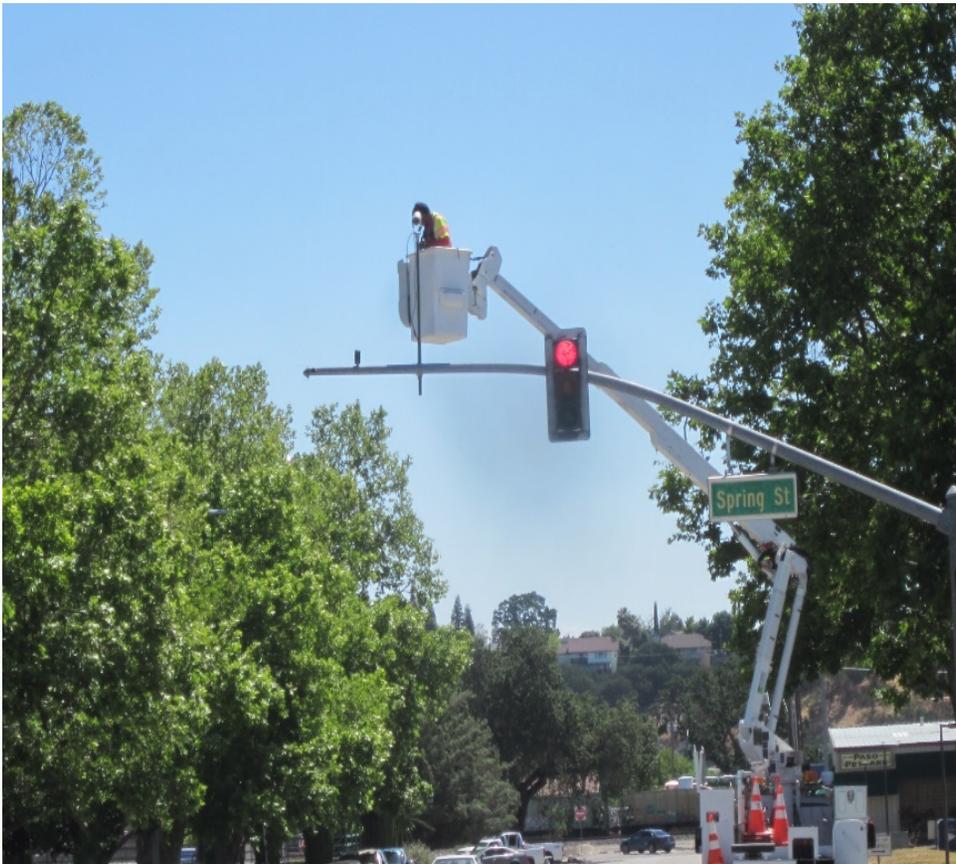
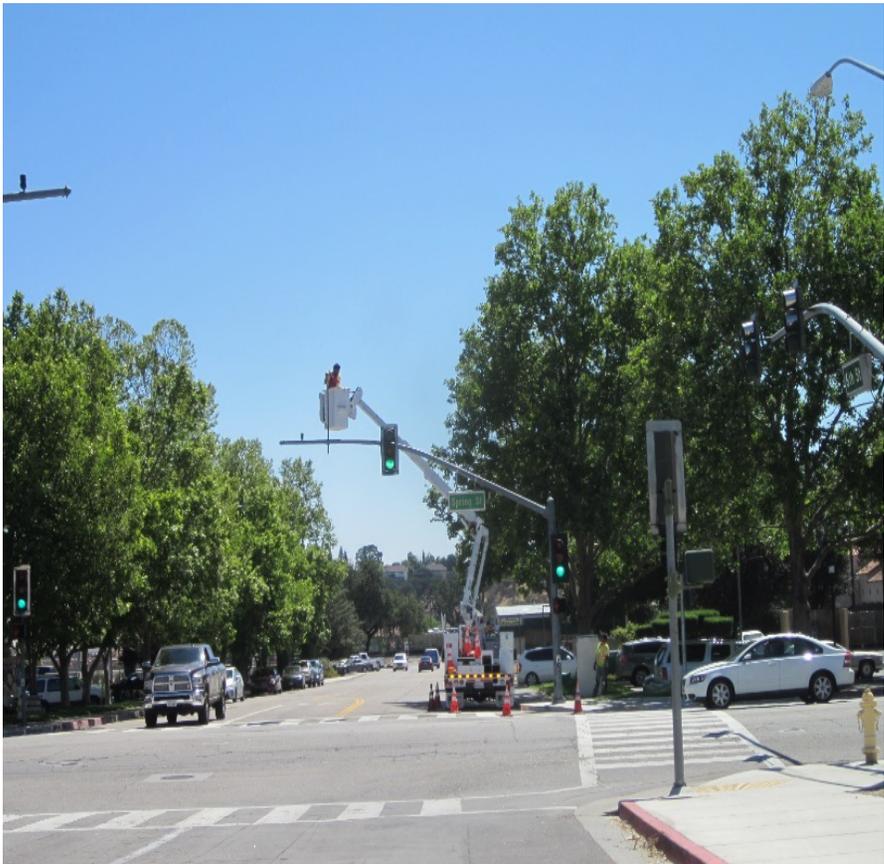
Contractor is also installing video detection cameras. This is in lieu of in-road loop detectors. (05/17/2016)
